Home Inspection Report

123 Main St.
Wildwood, MO 63025

Turn Key Home Inspections

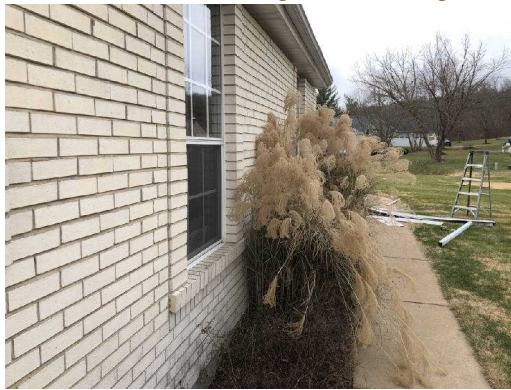
Grading and Vegetation: There was vegetation observed growing too close to the house. There should be adequate distance between the plants and wall coverings. Plants that touch wall coverings can physically damage them and create conditions for fungal growth. Recommend trimming back all vegetation that is touching the house.

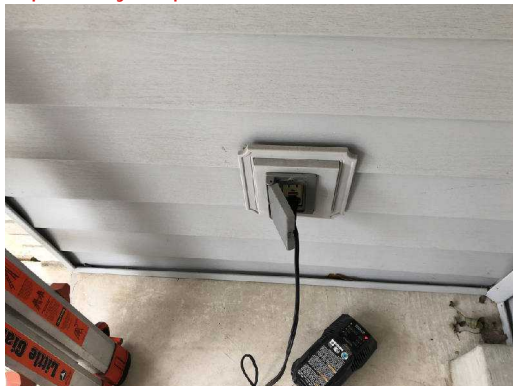
Electrical: GFCI outlet would not trip when tested(front and back of the house). GFCIs are a breaker or receptacle designed to shut off in the event of a ground fault. Current building standards require that all exterior outlets be protected with GFCIs. Recommend repairs by a qualified electrical contractor.

2. Electrical: GFCI outlet would not trip when tested(front and back of the house). GFCIs are a breaker or receptacle designed to shut off in the event of a ground fault. Current building standards require that all exterior outlets be protected with GFCIs. Recommend repairs by a qualified electrical contractor.

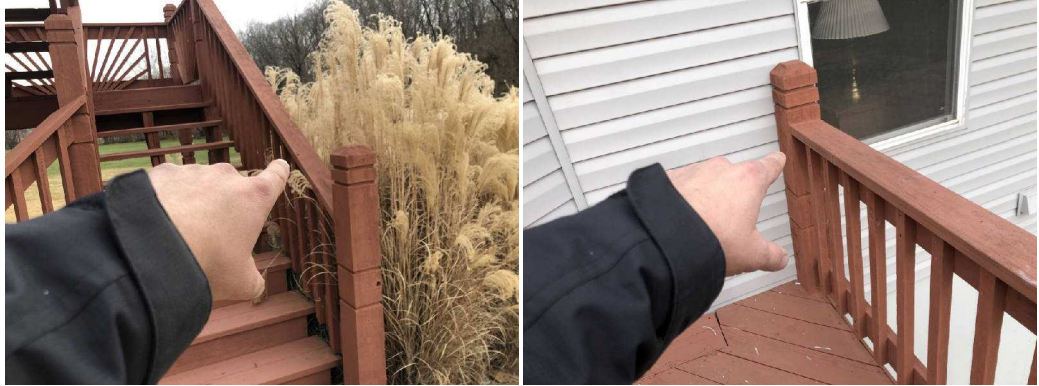
Stairs/Railings: Loose guard railing noted during the inspection. Railing should be built so they will resist a force of at least 200 pounds applied in any direction at any point. Lack of properly installed guardrail is a fall/safety hazard. Recommend repairs by a qualified contractor.

3. Stairs/Railings: Loose guard railing noted during the inspection. Railing should be built so they will resist a force of at least 200 pounds applied in any direction at any point. Lack of properly installed guardrail is a fall/safety hazard. Recommend repairs by a qualified contractor.
4. Post and Footing: Deck posts were observed to have wood rot or other deterioration. Damaged or deterioration wood support posts may not support the deck as intended and should be repaired or replaced as necessary by a qualified contractor.

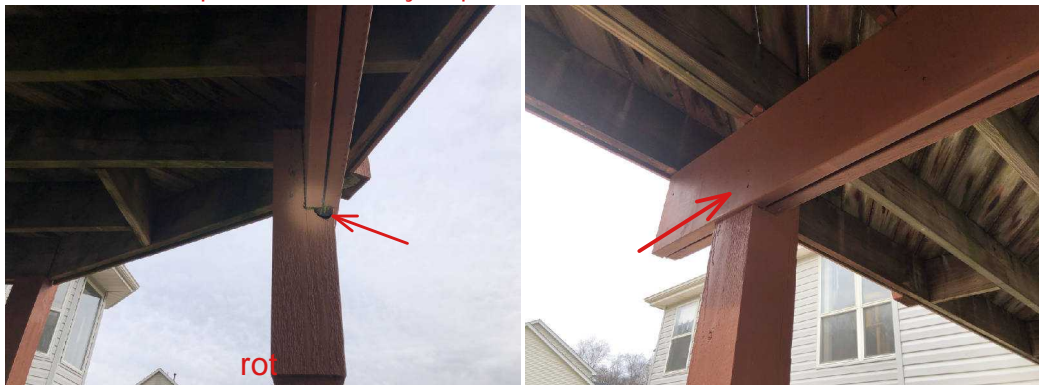
4. Recommend Upgrading Stairs/Railings: A graspable handrail was not provided on the back deck. Current building standards state that the stairway handrail grip should not be larger than 2". Stairway handrails that are not graspable are a safety hazard.

5. Defective Post and Footing: Deck posts were observed to have wood rot or other deterioration. Damaged or deterioration wood support posts may not support the deck as intended and should be repaired or replaced as necessary by a qualified contractor.

The post was observed to be improperly attached to the beam using only nails. Currents buildings standards require that post and beam be attached using 1/2" machine bolts. Recommend repairs be made by a qualified contractor.

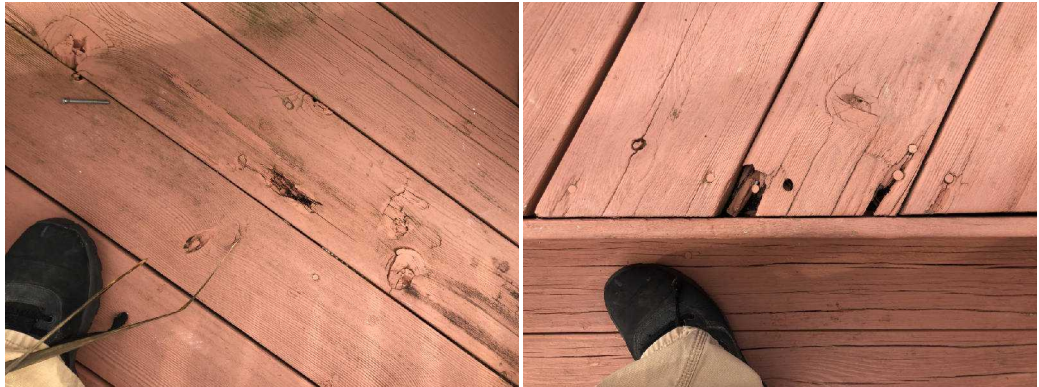
Decking: There was rot observed on the deck boards. Rot weakens the decking and causes distress to the deck. Damaged wood may need to be repaired or replaced and the conditions that have promoted the rot should be remedied. Recommend repairs be made by a qualified contractor.

5. Decking: There was rot observed on the deck boards. Rot weakens the decking and causes distress to the deck. Damaged wood may need to be repaired or replaced and the conditions that have promoted the rot should be remedied. Recommend repairs be made by a qualified contractor.
6. Ledger Board: Flashing is missing at the point of attachment of the structure. When installing a deck it is always recommended that flashing be installed behind the siding material that extends over the ledger board/band joist to prevent moisture from entering the structure attachment. Recommend further evaluation and repairs by a qualified contractor.

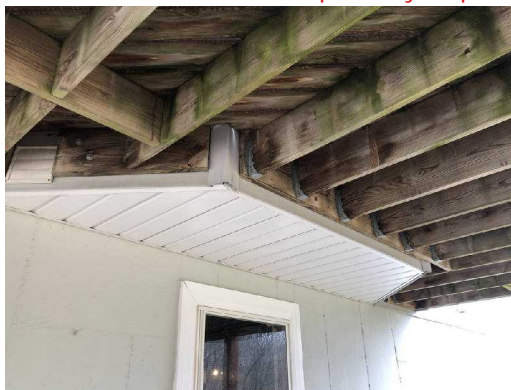
Ledger Board: Flashing is missing at the point of attachment of the structure. When installing a deck it is always recommended that flashing be installed behind the siding material that extends over the ledger board/band joist to prevent moisture from entering the structure attachment. Recommend further evaluation and repairs by a qualified contractor.

The ledger board was improperly secured to a cantilevered area of the home. Attaching the ledger board is prohibited if not done correctly due to the fact there is not adequate support from the cantilevered section of the home. This is because there is no support below the cantilever to keep the rim joist at the house from pulling loose. Recommend further evaluation and repairs by a qualified contractor.

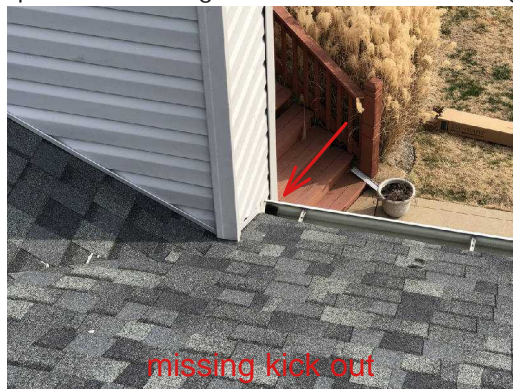
Flashings: Missing kick-out flashing during the time of the inspection. Current building standards require a kick out flashing at the roof covering and wall intersections. This type of flashing diverts water away from the siding and into the gutter. This will help prevent penetration of water into the house envelope. Recommend repairs by a qualified roofing contractor.

Missing drip edge flashing was noted at the time of the inspection. Drip edge flashing is a metal piece of flashing that is located at the edge of the roof and is meant to direct water away from the roof and into the gutter. Recommend adding drip edge flashing by a qualified roofing contractor when roofing material is replaced.

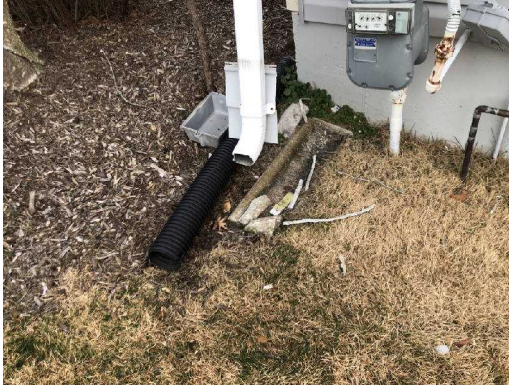
Gutters and Downspouts: The downspout extensions are not properly installed, missing, disconnected or tilting toward the structure. This is allowing water to accumulate around the foundation which is known to cause foundation problems when left unattended also moist areas around the home are attractive to termites. It is recommended that the downspouts be extended at least 6' away from the foundation of the home to help prevent foundation problems in the future.

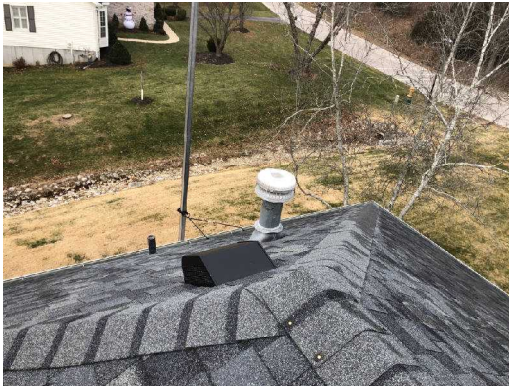
B Vent: The b vent serving the water heater and furnace was noted as being too short. Current building standards require that any b vent termination on a roof top have adequate clearance. This is to help the combustion gases exhaust properly and help prevent back drafting. Recommend repairs by a qualified HVAC contractor.

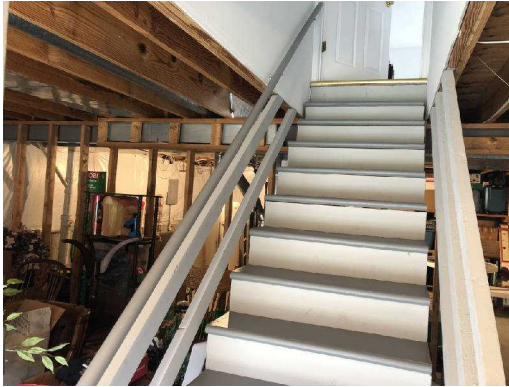
Stairs/Railings: The basement staircase height was observed to be inadequate and was a safety hazard(too low). Current building standards require the railing be at least 34" and no more than 38" above a sloped line connecting the stair treads. Recommend repairs by a qualified contractor.

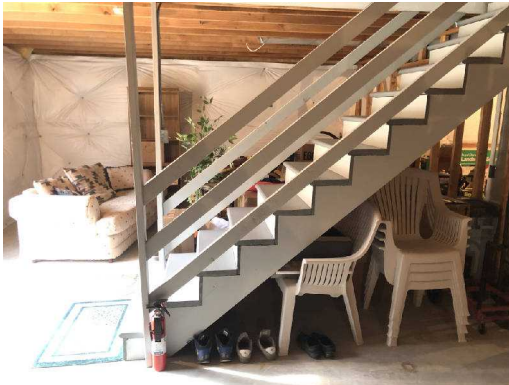
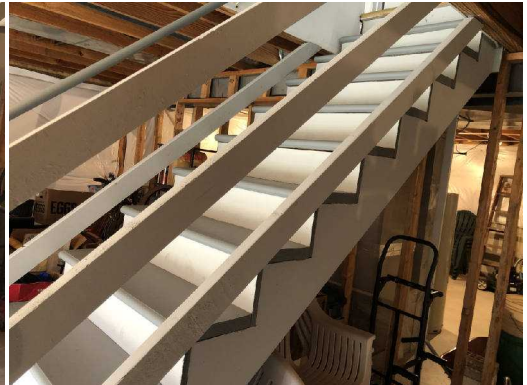
Stairs/Railings: Improper railing spacing noted during the inspection. Current building standards does not allow anymore than 4" space between the rails. This is a safety hazard for small children Recommend repairs by a qualified contractor.

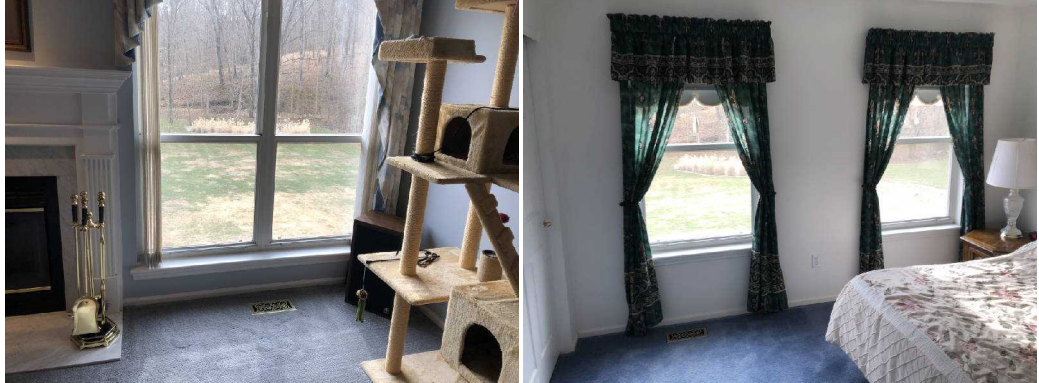
Windows and Screens: It was noted that the window in the bedroom and living room were too low to the floor. Current building standards require that any window that is more than 72" above grade and the window sill is less than 24" above the floor be required to have fall protection that does limits any opening to be less than 4". This presents a fall safety hazard and protective measures should be taken to prevent falls. Recommend repairs be made by a qualified contractor.

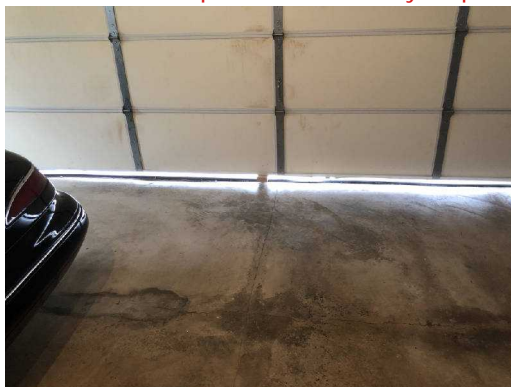
Garage Doors: The pressure reversing sensors did not activate when tested. Pressure sensors provide entrapment protection for motor operated doors. This is a safety concern. Recommend repairs be made by a qualified contractor.

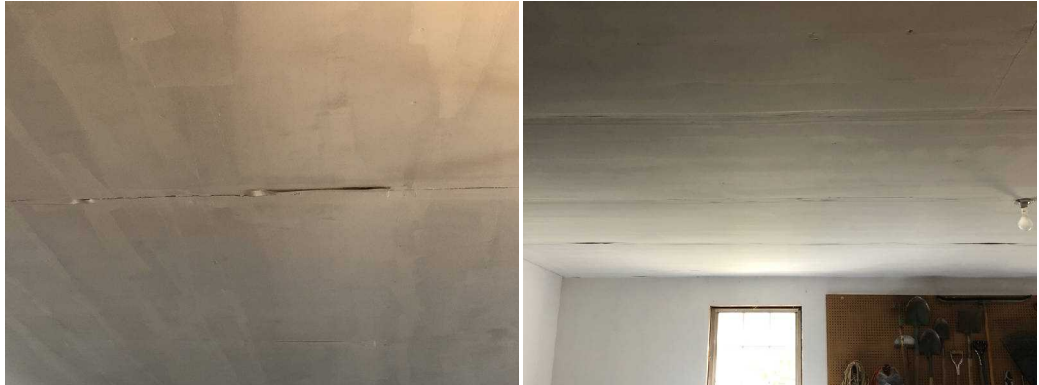
Ceiling and Walls: Loose drywall seams noted during the inspection. The openings could allow hot gases to travel into the home quicker. For optimal protection the joints should be sealed. Recommend repairs by a qualified contractor.

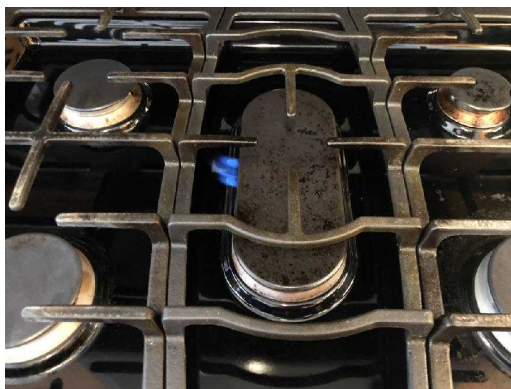
Cooking Appliances: The burner was not fully functional during the inspection. The cause of the burner not working should be determined and repaired as necessary by a qualified contractor.

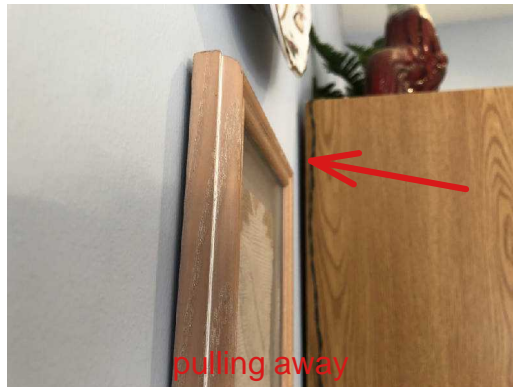
Counter/Cabinets: **The wrong type of screws were installed to secure cabinets to the walls. This has allowed the cabinets to pull away from the wall. Screws rated for this type of installation are recommended[cabinet screws]. These types of screws have better shear strength. Recommend repairs by a qualified contractor.**

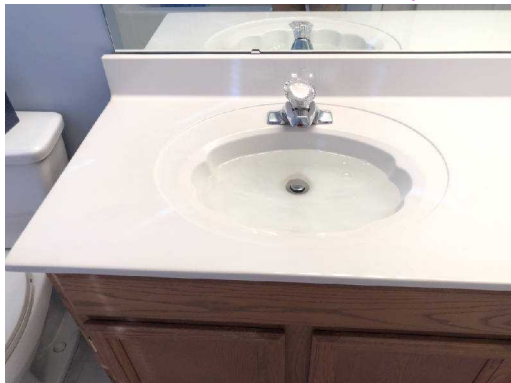
| 5. Recommend Upgrading | Plumbing: Missing shut-off valves on the faucets(both bathrooms). Current building standards require all fixtures to have shut-off valves besides baths and showers. Recommend upgrades by a qualified plumbing contractor. |
| 6. Maintenance Item | Plumbing: Slow drain was observed in the bathroom sink. The cause of the slow drain should be determined and repaired as necessary by a qualified plumbing contractor. Recommend an evaluation and possible repairs by a qualified contractor. |

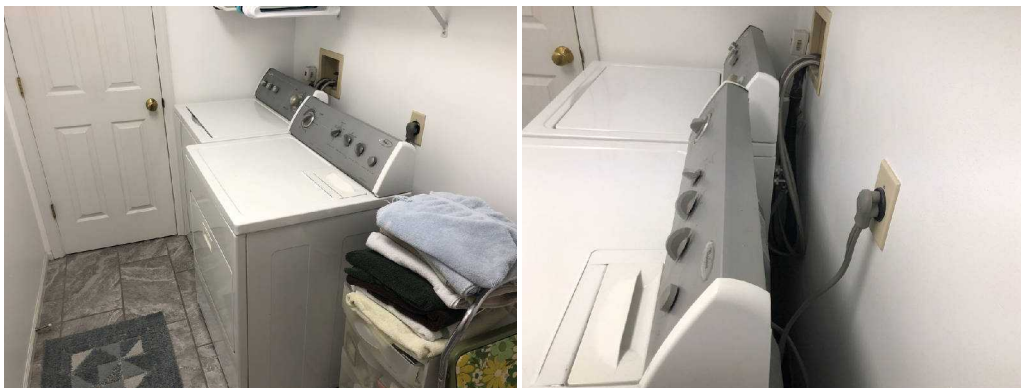
2. Recommend Upgrading Electrical: **The washing machine electrical connections were observed to lack ground fault circuit interrupter [GFCI] device protection. According to current building standards all laundry room electrical receptacles including the washing machine electrical connection should have GFCI protection. Lack of GFCI protection in required locations is a safety hazard. Recommend upgrades by a qualified electrical contractor.**

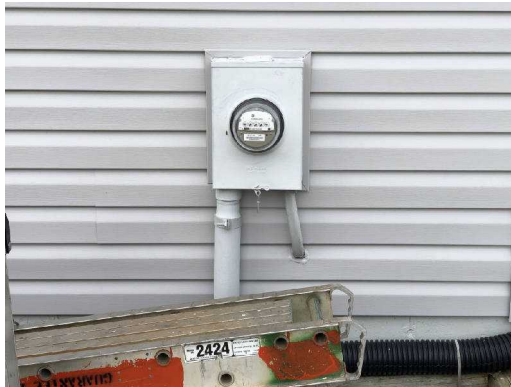
4. Acceptable Conductor Type: Non-metallic sheathed cable
5. Recommend Upgrading Ground: **No grounding rod was noted during the inspection. Current building standards require 2 sources of ground for the main dwelling. This is to provide a path for lightning and provide personal protection. Recommend upgrades by a qualified electrical contractor.**

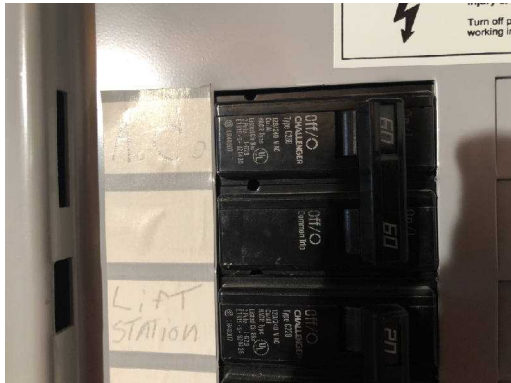
Breakers/Fuses: Mismatched breaker sizes between the exterior HVAC equipment [Max/Min amperage], electric disconnect and/or the service panel breaker were observed. This can allow the unit to draw more power than it can handle without the breaker tripping allowing the circuit to overheat. This is a fire/safety hazard. Recommend further evaluation and repairs by a qualified HVAC contractor.

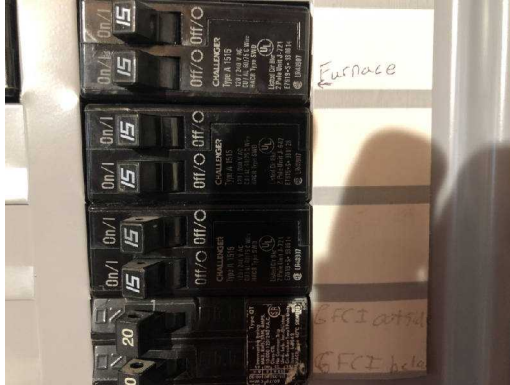
Breakers/Fuses: The electrical service panel breakers were not properly labeled. Each electric service panel breaker should be adequately labeled as to what appliance or circuit it serves. Recommend having circuits labeled prior too closing.

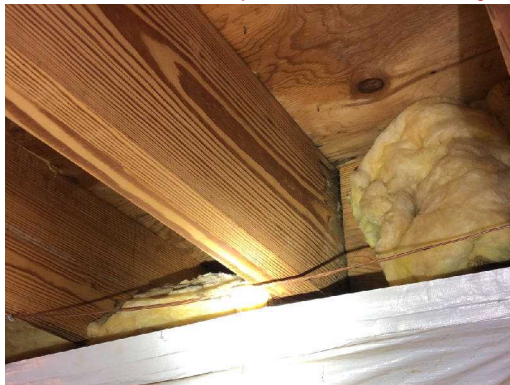
Joists/Trusses: **Water damage was observed on the floor joist. Water damage can cause rot that can weaken the structural members. The cause of these water damage should be determined and repaired as necessary by a qualified contractor.**

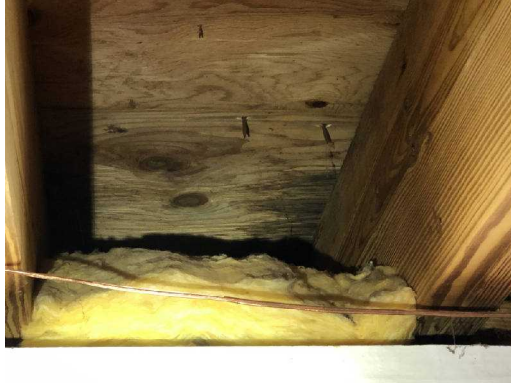
8. Recommend Monitoring Subfloor: [Water staining was observed on the subfloor during the time of the inspection. Recommend monitoring this area for any changes and repair as necessary by a qualified contractor.](#)

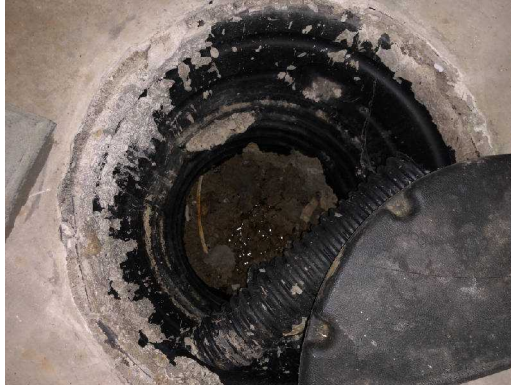
6. Recommend Monitoring Sump Pump: There was a sump pit noted with no pump. The pit was dry at the time of the inspection. Recommend monitoring.

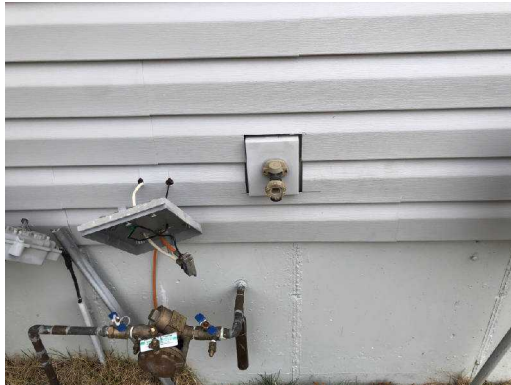
Hose Bibs: The hose bib was observed as inoperative, disconnected or have no water flow during the time of the inspection. The cause for the hose bib being inoperative should be determined and repaired or replaced as necessary by a qualified plumbing contractor.

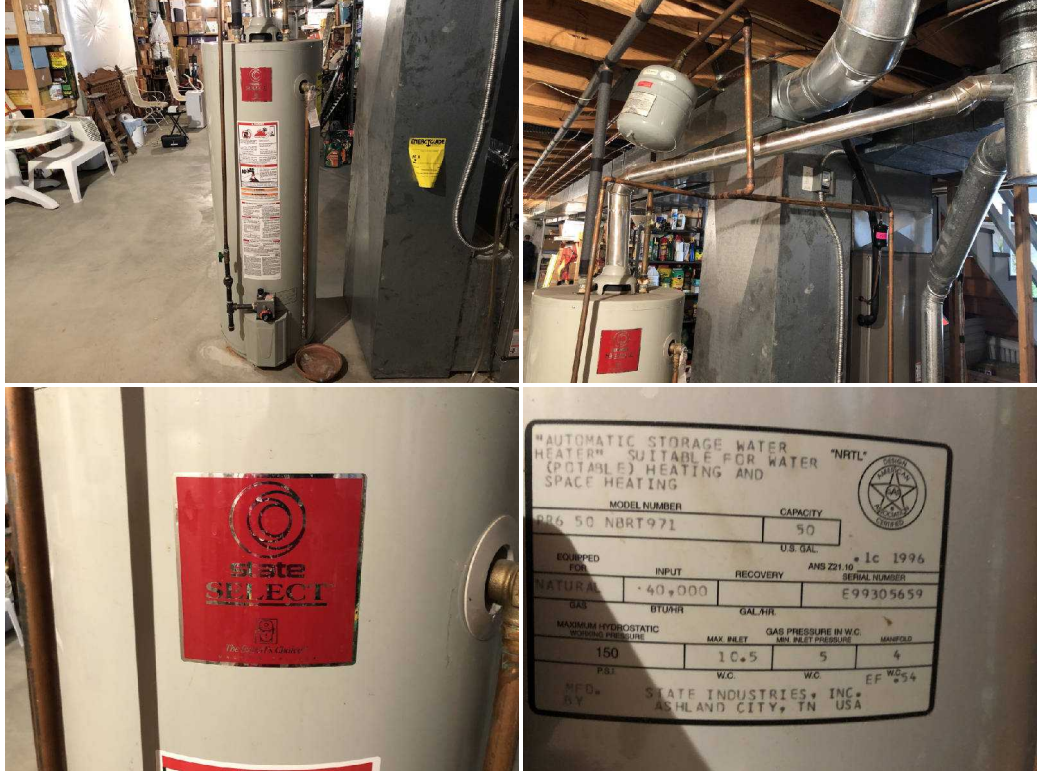
Water Heater Operation: The water heater appeared to be past the end of its lifespan and the future life expectancy cannot be determined. The average lifespan of a water heater is about 10-12 years depending on usage and other factors. Yearly maintenance and close monitoring for rust, leaks or other defects is recommended. You can continue to use and service the water heating equipment until replacement is necessary.
