Inspection Report

RE: 709 Summer Oak Dr., Ellisville, MO 63021

POOL/SPA & EQUIPMENT

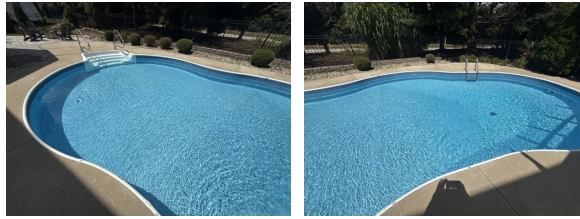
**SURFACE DEFECT(S)**

* Vinyl Liner was faded, or had faded areas, at time of inspection. Fading possibly due to various reasons (ex. weathering, chemical damage, robot cleaner, etc.).

Did NOT appear to affect the operation of the pool.

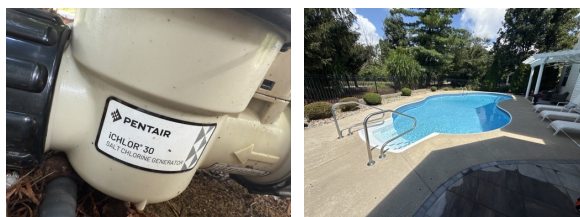
**ALARM(S) / SAFETY ROPE****NO POOL ALARM**

Pool alarm was NOT available at time of inspection. This is a **SAFETY ISSUE**.

Recommend alarm be installed per safety standards.

Recommend getting estimate(s) of this install.

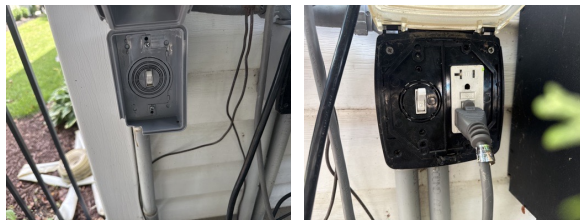
INDEPENDENT SWITCH SATISFACTORY

Independent Shut-off switch operating within normal limits at the time of inspection.
