Home Inspection Report

123 Main St.
Wildwood, MO 63025

Turn Key Home Inspections

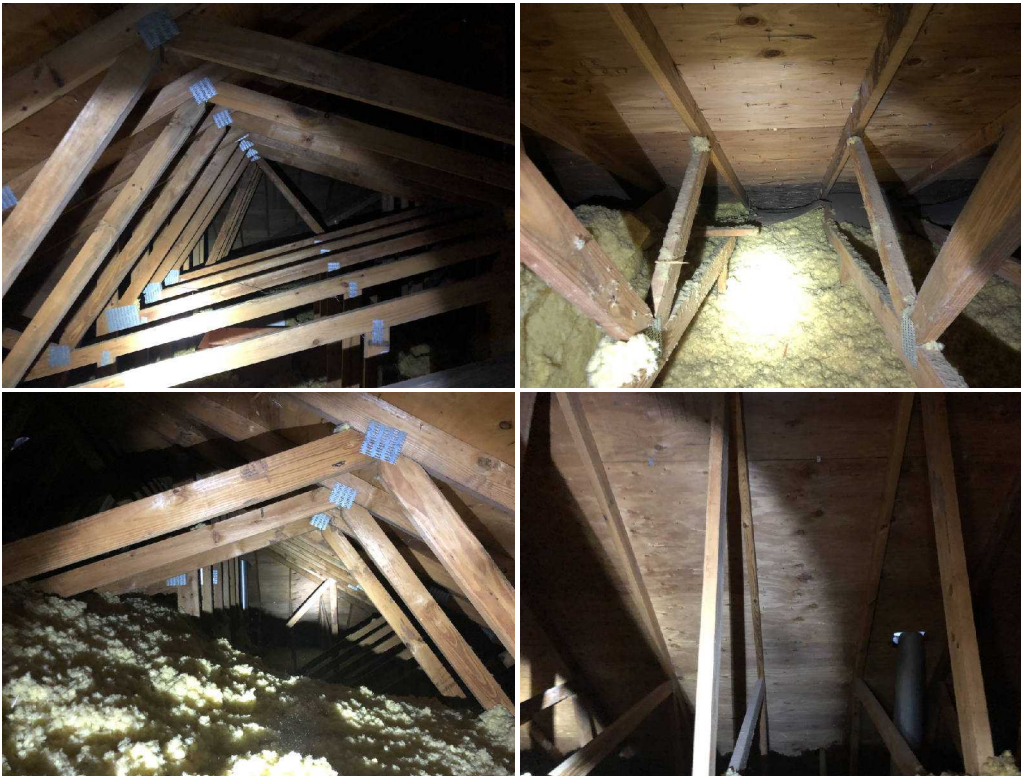
Main Attic

3. Acceptable
 4. Acceptable
 5. Acceptable
 6. Acceptable
 7. Acceptable
 8. Acceptable
 9. Recommend Upgrading
- Unable to Inspect: 50%
Roof Framing and Sheathing: Truss
Attic Access: No concerns noted
Ventilation: Soffit Vents, Roof Vents
Insulation Type and Depth: Blown in fiberglass
Wiring/Lighting: No concerns noted
Bathroom Fan Venting: The bathroom fan improperly vents directly into the attic. This can cause condensation on roof members and insulation which could eventually cause mold. Recommend evaluation and correction by a qualified contractor to allow for the vent to be routed to the exterior of the home.
